Why is Mayaguez's viaduct collapsing?

By Wallace J. de la Vega

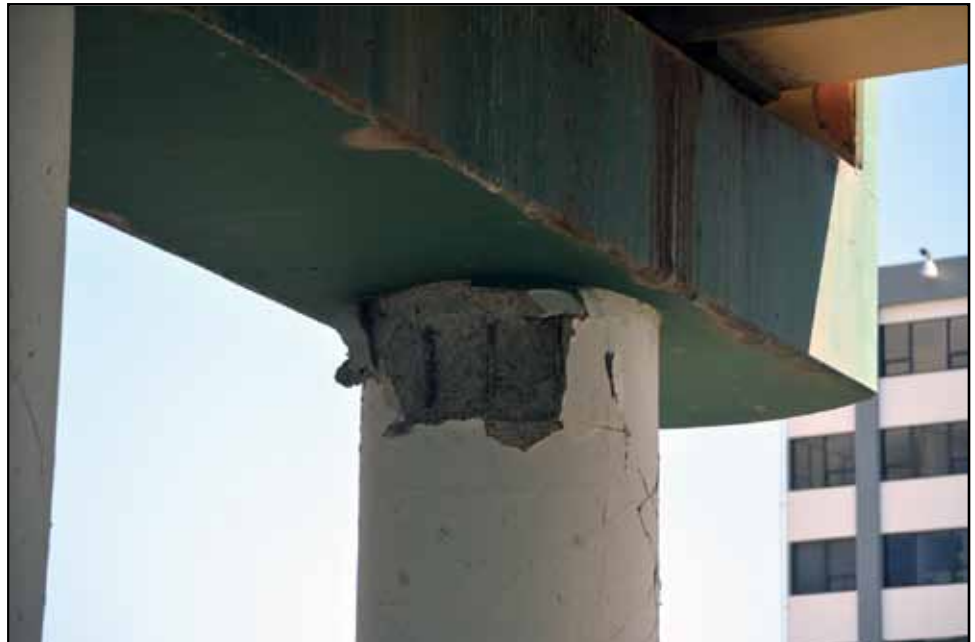
Damage to a new column.
